## The Design and Construction of New Mizen Head Footbridge

# The Design and Construction of New Mizen Head Footbridge

## Overview

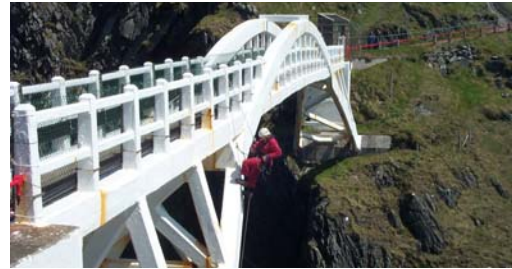
For over 100 years, CIL has carried out maintenance activities on the bridge. A maintenance contract was undertaken in 2000 for repainting the bridge and carrying out concrete repairs. An inspection by CIL engineers at this time revealed areas of spalled concrete and severe reinforcement corrosion, particularly at a joint between a deck hanger and the northern edge beam. In 2002, CIL appointed RPS (then M.C. O’Sullivan and Company Ltd.) to conduct an inspection and structural assessment of the footbridge. Specific information on the structure was collected by material tests, observations and geometrical surveys. This information helped to establish the condition of the structure and provide material and geometric parameters for analytical models and for maintenance, repair or strengthening scheme development. The defects noted during the inspection may be summarised as rust staining, areas of hollow sounding concrete, cracking and localised

areas of missing concrete. All the defects noted were related to corroding reinforcement. No defects caused by structural actions were observed. In general, the visual inspection of the bridge found it to be in good condition given its age and its location in an exposed site<sup>4</sup>. This was due to the quality of the original construction and to CIL who have regularly maintained and repainted the bridge over its lifetime.

**Figure 5: Inspection by roped access in 2002**

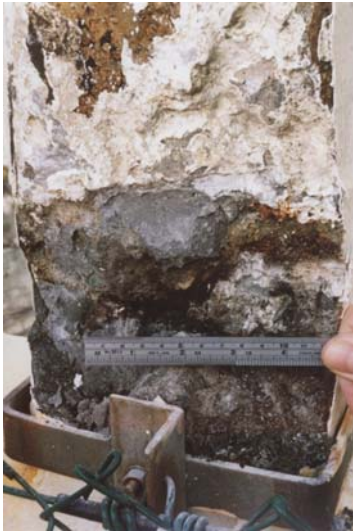
Concrete was broken out locally in two hangers to examine the condition of the reinforcement. The reinforcement in the first break-out was found to be in very good condition. The reinforcement in the second breakout was found to have disintegrated in to a fine black dust without the formation of expansive product (Figure 6). This is an unusual form of steel anaerobic corrosion and it is the subject of ongoing research.

**Figure 6: Breakout of Hanger N19 in 2002. Original flat bar reinforcement had disintegrated in to a fine black dust without expansive product.**

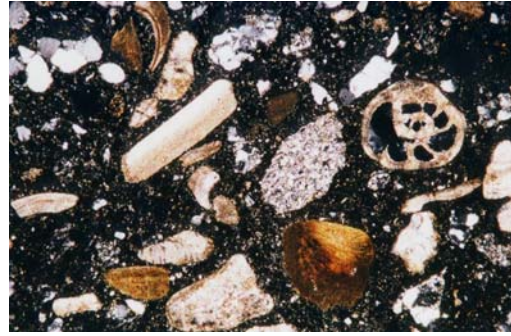
The fine aggregate contained abundant shell fragments, which were derived from a marine source, probably a beach sand (Figure 7). Samples of sand were taken from nearby Barley Cove during a visit to the site and examined in the laboratory using the petrological microscope. This material closely resembled the shell fragments found in the deck concrete and given the close proximity of the beach to the bridge it is likely that Barley Cove was the source of fine aggregate used in the deck.

**Figure 7: Petrographic analysis of the original bridge concrete showing presence of sea shells**

No evidence of damage due to alkali-aggregate action was found in the petrographic examination, although traces of gel were present in voids in the paste. Examination of a thin section taken from a portion of the core sample showed fine cracks running through aggregate particles into the cement paste. These were found to contain alkali silicate gel and indicated that an expansive reaction had taken place between the greywacke aggregate and alkalies in the paste, causing very localised damage to the concrete in the area where the core had been taken. This is considered to be the only reported example of alkali-aggregate reaction in Ireland to date.

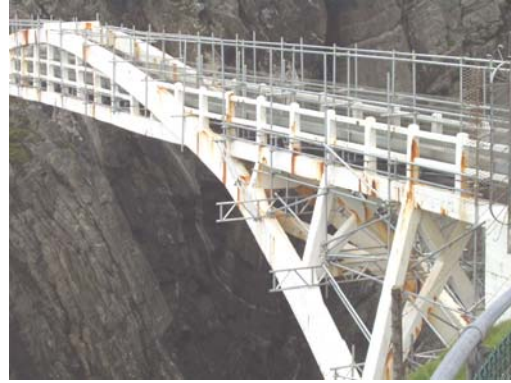
**Figure 9: Temporary access scaffold supported directly from the arch ribs erected in June 2005.**

Following the issue of the Electrical Continuity Testing Report to CIL, the Mizen Footbridge was closed to pedestrian traffic. In June 2005, RPS under the direction of CIL procured an access scaffold for the bridge. The scaffold was supported directly from the arch ribs only and provided an independent bridge deck for the structure. The scaffold allowed access to be maintained at Mizen Head until a permanent solution was developed (Figure 9). It was expected that the scaffold would have a lifespan in the region of 3 to 5 years.

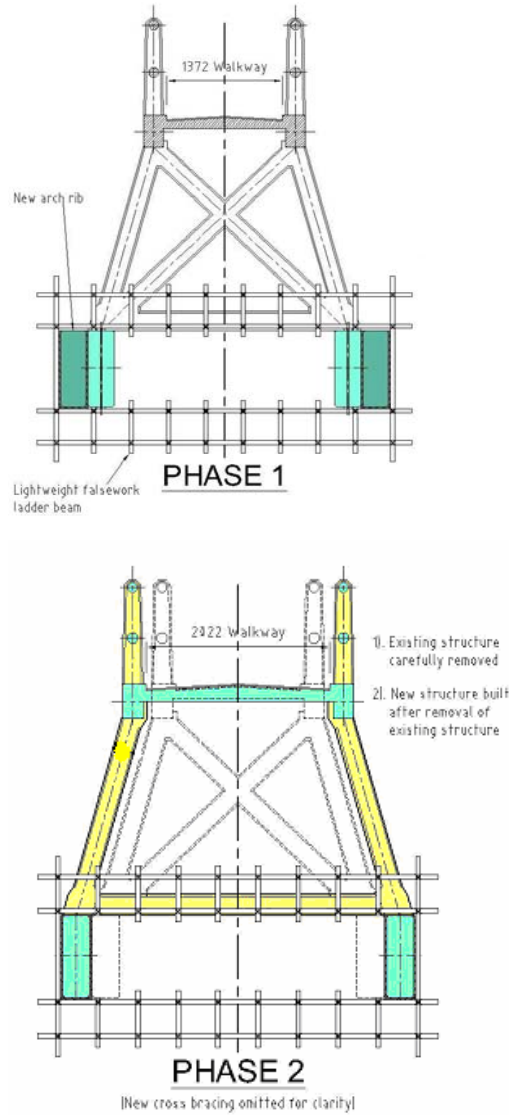
**Figure 10: Sectional elevations through the bridge indicating the solution to use the existing ribs as falsework for the construction of new ribs. The new ribs would then be used to support demolition works on the old bridge.**

Option 2 was recommended as the preferred option as it maintained the current appearance and form of the bridge, it gave the best long term solution and provided an economic solution which could be built safely with minimal impact on the environment. Figure 10 outlines the solution.

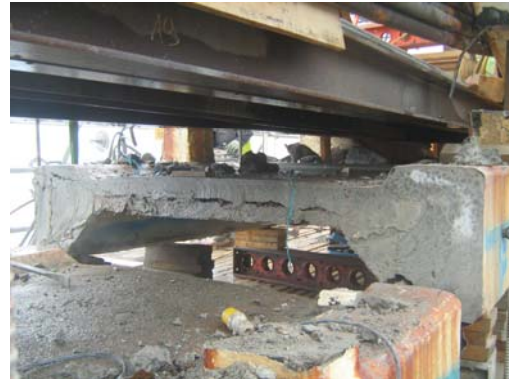
**Figure 18: Demolition of the bridge deck by wire saw-cutting.**

The existing deck was propped off the temporary deck and the hangers were removed using circular saws. The existing deck was wire-cut in to pieces which were lowered on to the temporary works deck and removed with the overhead winch. (Figures 18 and 19). Formwork was installed for the new deck and edge beams, reinforcement was fixed (Figure 20) and the new elements were poured. New hangers were subsequently fixed and poured.

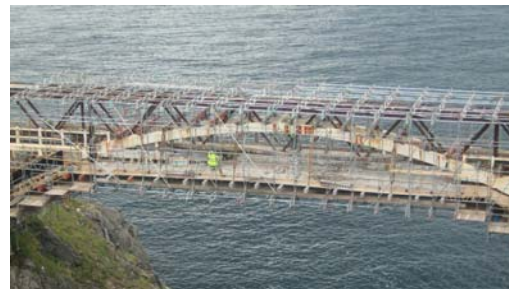
**Figure 19: Original deck and hangers removed from the bridge.**

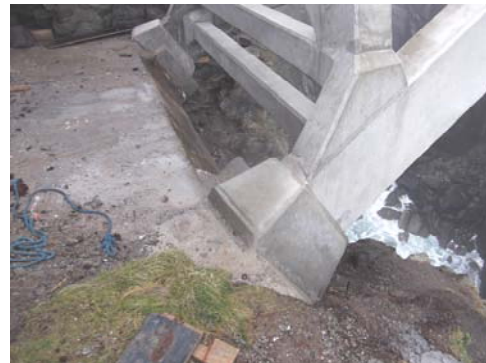
Figure 29: Completed bearing detail with the original arch rib springing points remaining in place.

The final structural elements to be constructed were the braces between the ribs in the back-spans and the section of deck which is composite with the arch ribs at the quarter-span points (Figures 27 and 28). Following this, the main temporary works were sequentially dismantled and removed from the site. The Meysenard hinges were grouted and the remains of the original arch ribs were finished in concrete to provide a legacy of the original structure (Figure 29).
