## The Design and Construction of New Mizen Head Footbridge

# The Design and Construction of New Mizen Head Footbridge

## Overview

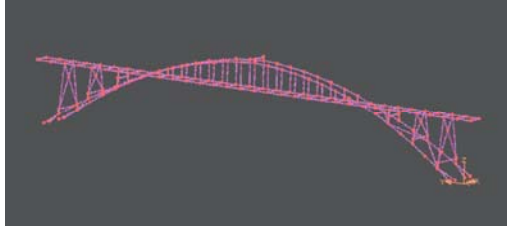
**Figure 8: Part of the finite element model used for bridge assessment**

Based on the original construction drawings and the information gathered during the principal inspection, RPS carried out a finite element assessment of the structure (Figure 8). Structural member stiffnesses were calculated neglecting the cover layer concrete. Structural member resistances were calculated using half the reinforcement indicated in the construction drawings. The results indicated that the structure was adequate for continued use due to good reserves of structural resistance to applied dead and live loading effects.

However, given that the central suspended span of the deck was relying on reinforced concrete hangers in direct tension and given the high chloride induced steel corrosion throughout the structure, it was recommended that the hangers be strengthened and that measures be taken to halt the corrosion of reinforcement in the structure. A monitoring regime was placed on the structure to allow regular inspections at six-monthly intervals.

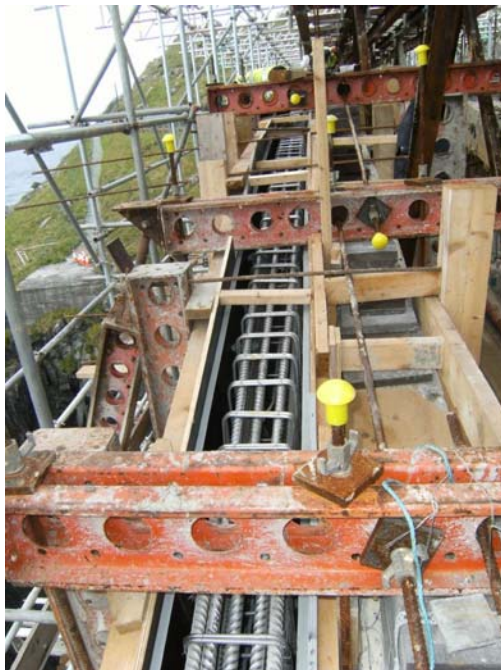
**Figure 21: Southern rib arch reinforcement. The original rib is visible on the right hand side.**

The original arch ribs were used to support falsework for the new ribs. This was an effective way of undertaking the initial setting out for the new ribs. Figure 21 shows the southern arch rib reinforcement in the formwork. Extensive use was made of stainless steel reinforcement couplers throughout the works as there was not enough space for starter bars and the new structural elements were often face to face with original structural elements prior to demolition activities. The correct setting out of these couplers was achieved through the use of plywood templates based on 1:1 drawings prepared by RPS and verified by Irishenco. This was an important consideration as the different structural elements of the bridge intersect at varying angles and a misplaced coupler would have been problematic to rectify.

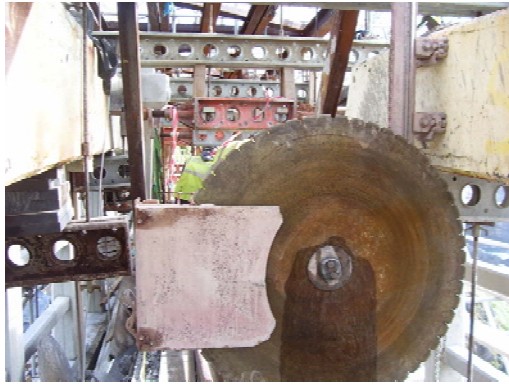
Figure 24: Use of circular saws for demolition.

Prior to the demolition of the original ribs, all of the temporary works which were relying on the original ribs for support were transferred to the new ribs. As both sets of ribs were located at the same level, the exercise involved a careful inspection of the myriad of support details to ensure that all loads would be transferred smoothly. It was essential that no temporary works element could snag on other elements on removal of the original ribs. Such a situation could give rise to a suddenly applied load and a crush injury hazard. Supports were also adjusted so that the original ribs would be supported from the new ribs. The new ribs were also braced off each other for stability. Hinges were cut in to the original ribs at the springing points. Finally hinges were cut in to the crown of the original ribs. These were gradually reduced and eliminated so that the original ribs were directly supported by the new ribs. Demolition of the ribs now proceeded through the use of concrete circular saws, coring and mechanical expansion jaws (Figures 24, 25 and 26).

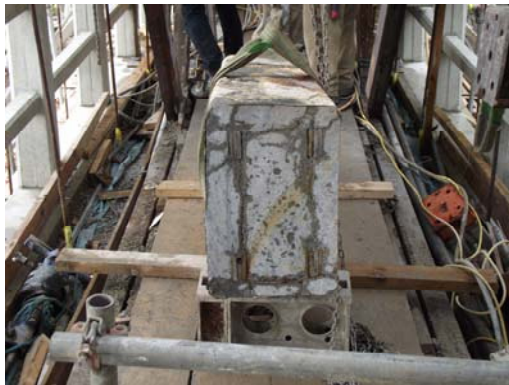
Figure 25: Section of demolished arch rib.

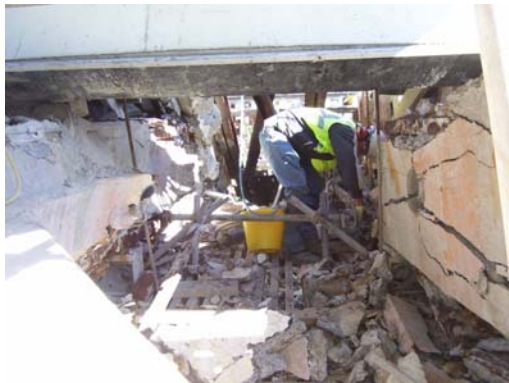
Figure 26: Demolishing the ribs and braces in the back span.
